FIELD DATA SHEET 1

WESTBANK ASBESTOS REMOVAL PROJECT NEW ORLEANS, LA

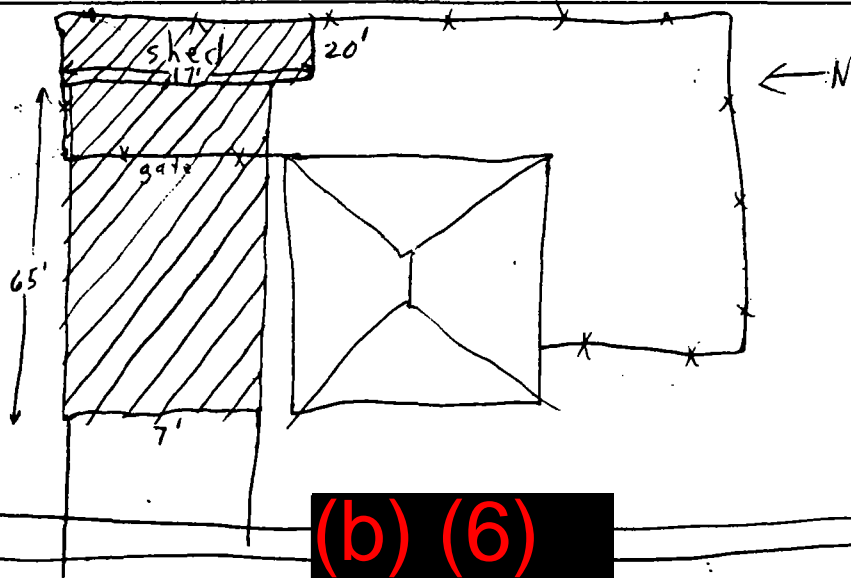
① = ACM

Comments: owner will remove shed prior to removal activities so ACM can be excavated from shed floor.Backfill: discuss w/ [REDACTED] prior to replacement. He may want concrete and limestoneDate/Time of Interview: 11/22 / 0845Access Granted (circle): yes; noTeam Members: JM/AR

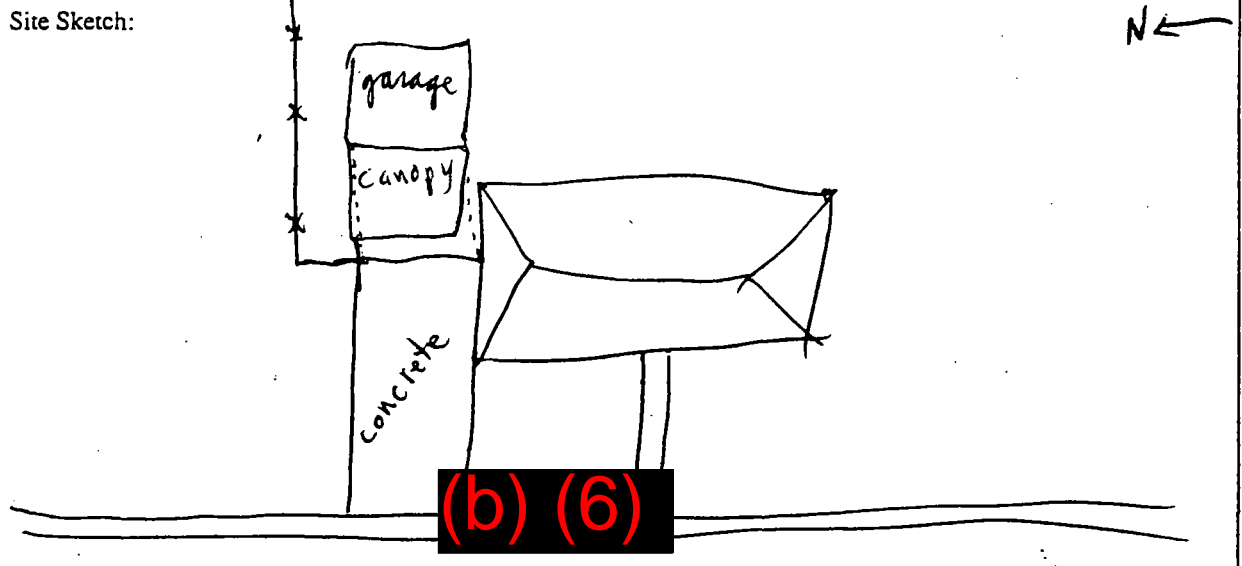
Comments: No visible ACM. Owner suspected ACM could be mixed in with driveway concrete. Our field assessment did not indicate typical ACM material. The concrete paving was "soft", but in good condition. (over)

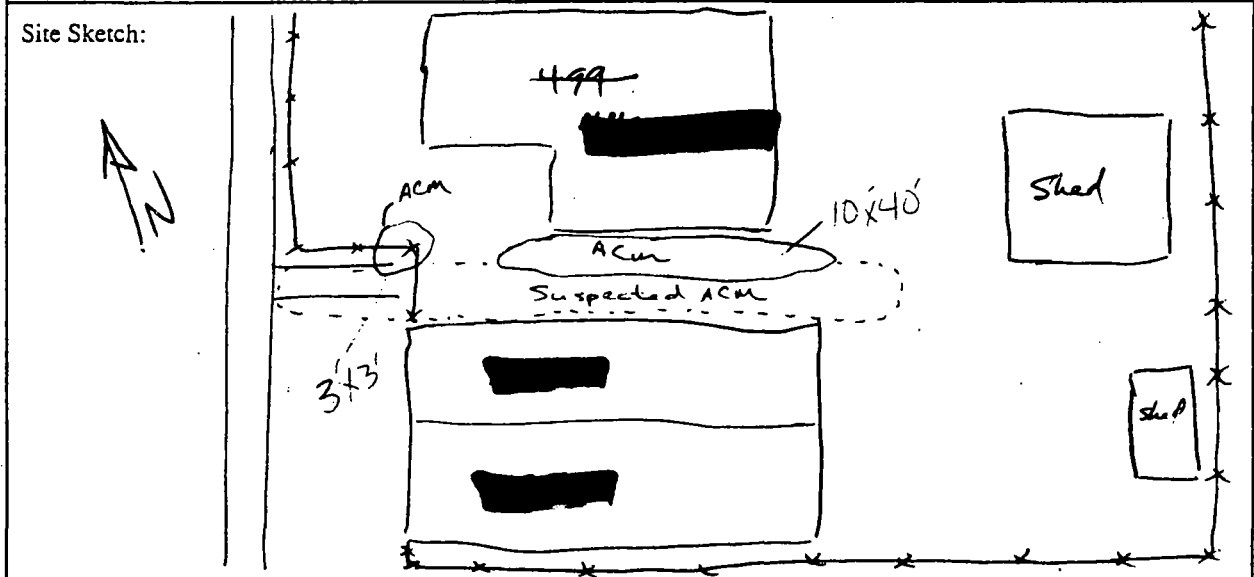
4) Is any underground ACM present? (circle): yes; no; don't know
If yes, note on site sketch. How deep? suspect larger area than is visible

Estimated Volume of ACM: unknown

Comments: Owner owns both projects at 499 and 455
11/26/96 - need to call about replacement material

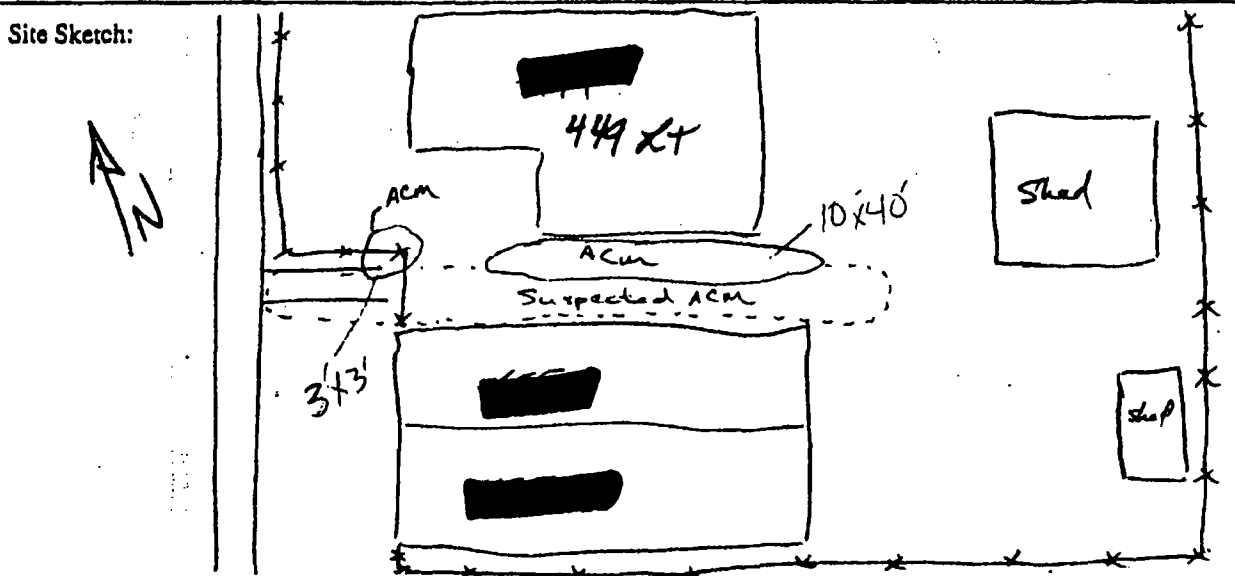
Estimated Volume of ACM: unknownComments: Owner owns both properties at 499 and 455
11/26/96 - need to call about replacement materialDate/Time of Interview: 11/25/96Access Granted (circle): yes; noTeam Members: G. Day

NO new rock! Will replace driveway area with concrete ^{area} comparable to ~~the~~ pad in the back. If area is smaller, will make arrangements, if area is bigger, will form area for Mr. Mack to pour own concrete. Please call before coming so he can schedule diggs, etc.

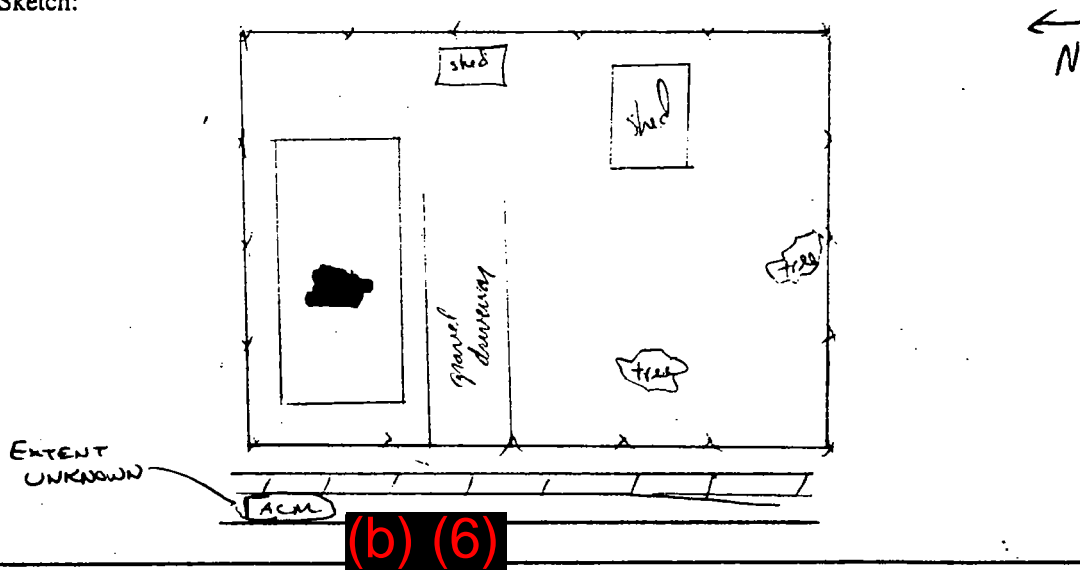
Comments: No visible ACM; KS/TC visited this house once before and found no vis. ACM.
5/15/97 → ACM found in servitude during excavation of site 1087 next door.
No one home 5/15/97 site 1007 removal went into site 932 - Tim 10:37 hrs. *GRB*

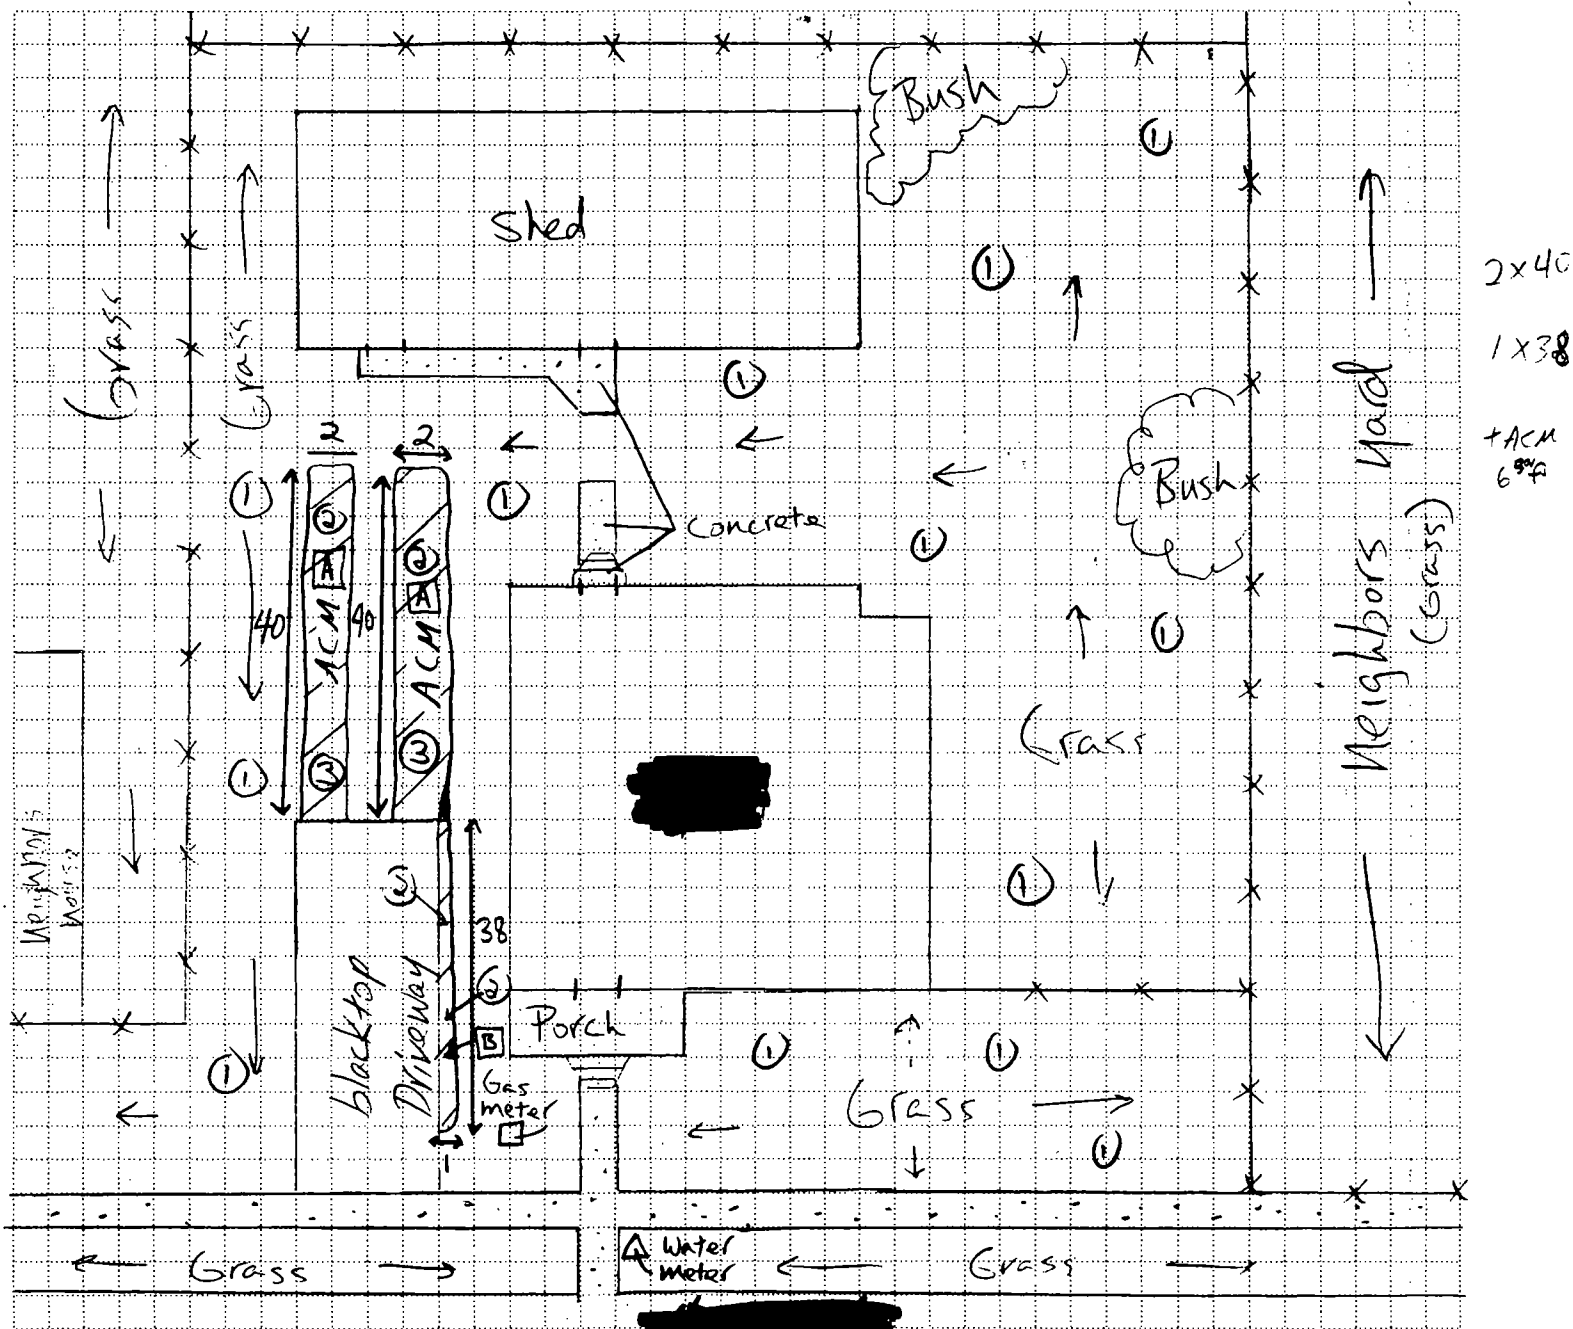
Some SACM present in Runners
about 6 sq. ft. total
SUSPECTED ACM UNDER 3"-4" OF ASPHALT
THAT IS IN GOOD CONDITION (DRIVEWAY)

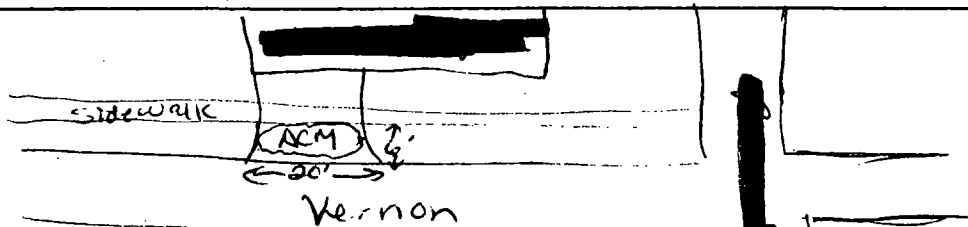
1/8/97 -- [REDACTED] stopped to obtain signed access agreement. ACM is no longer in driveway. It has been broken up and scattered along the sidewalk. New concrete slab is in place now. We notified [REDACTED] of this via radio upon discovery.

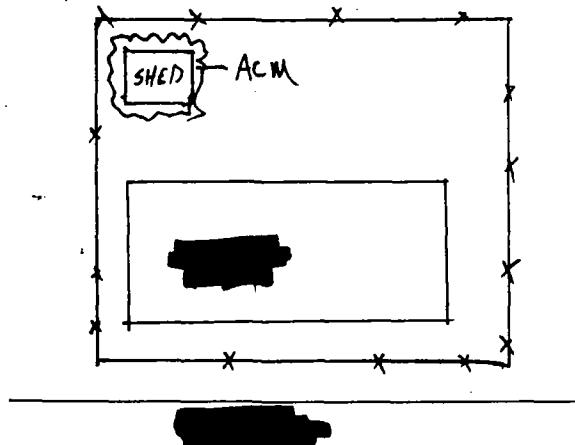
Comments: ACM UNDER SHED - EXTENDS ~ 1 FOOT OUT FROM BASE + WALLS - SHED FLOOR - POURED CONCRETE. Owner wants soil replaced ground shed.Date/Time of Interview: 2/12/97 0904Access Granted (circle): yes; noTeam Members: CMA/KR

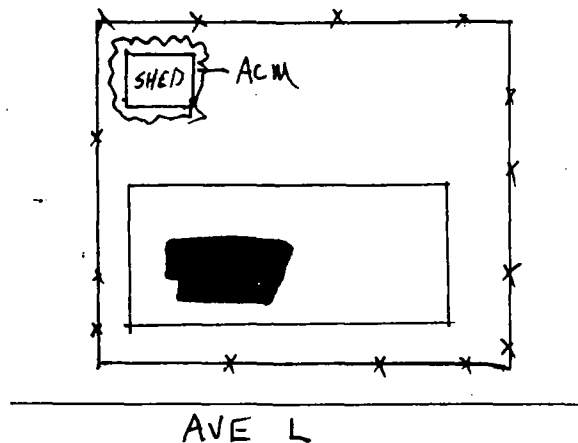
Comments: ACM UNDER SHED - EXTENDS ~ 1 FOOT OUT FROM BASE + WALLS -
SHED FLOOR - POURED CONCRETE. Owner wants soil replaced
around shed
